INGERSOLL TOWN HALL

HISTORY AND ARCHITECTURE
Analysis and Conservation

prepared by
NICHOLAS HILL
Architect Planner

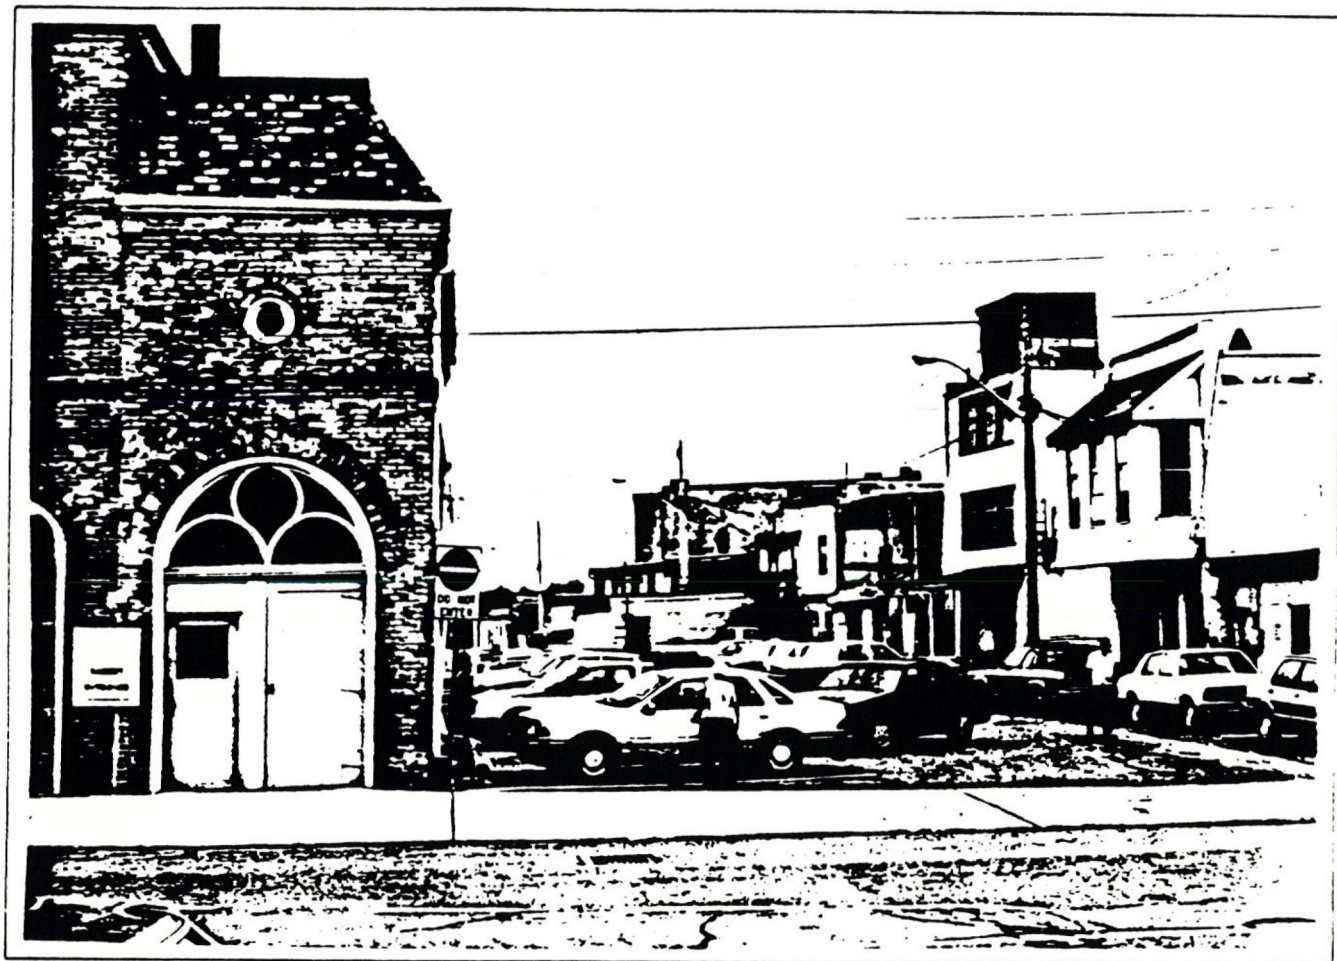
SETTING

Landscaping is required to set the Town Hall off from the car parking and backs of blocks to the north and east.

Italianate style with an emphasis on water by way of a focal fountain. Most certainly a landscaped buffer area is required to separate the setting of the Town Hall and the car parking and backs of blocks to the north and east.

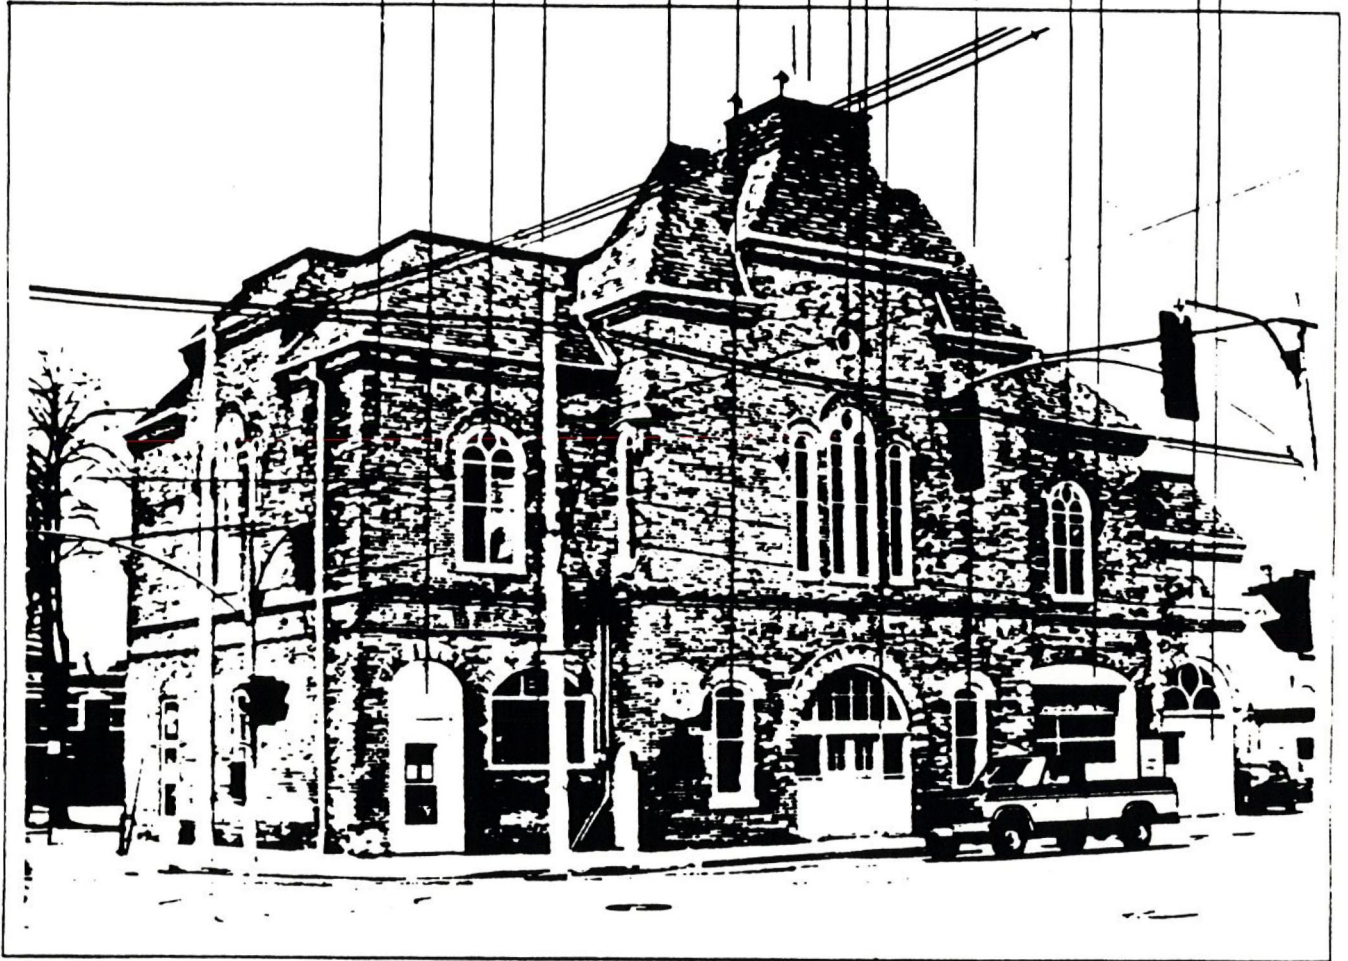
south elevation analysis

The east front addition of circa 1876 is well integrated in scale and detail and does not undermine the building's design. However, the removal of the belfry was a major loss which should be redressed when structural stability is restored.

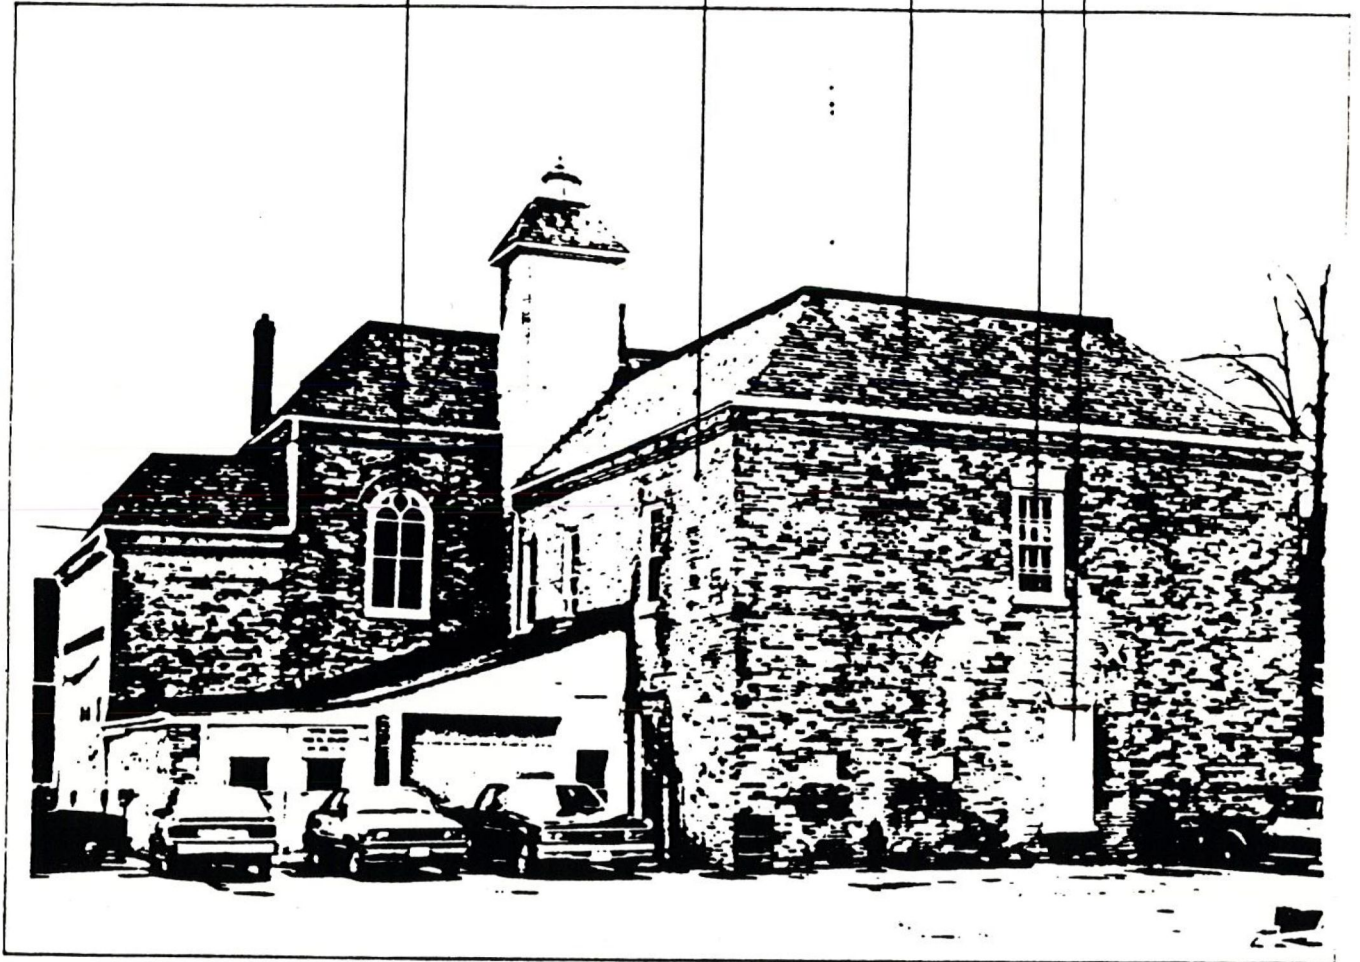
north elevation analysis

Analysis: There is considerable deterioration of the brickwork on both the rear wing north face, where the lower four feet show spalling and loss of mortar, and on the main block east wing, which has a long crack on the north wall between first and second storeys. The front addition, to the east, appears to be pulling away from the main block. Two metal tie rod ends flank the centre of the rear addition north wall and a vent pipe projects below the more easterly of the two. A rainwater leader is attached to the north wall of the main block at the west end of the building.

Conservation: Considerable repair of brickwork is required on this elevation.

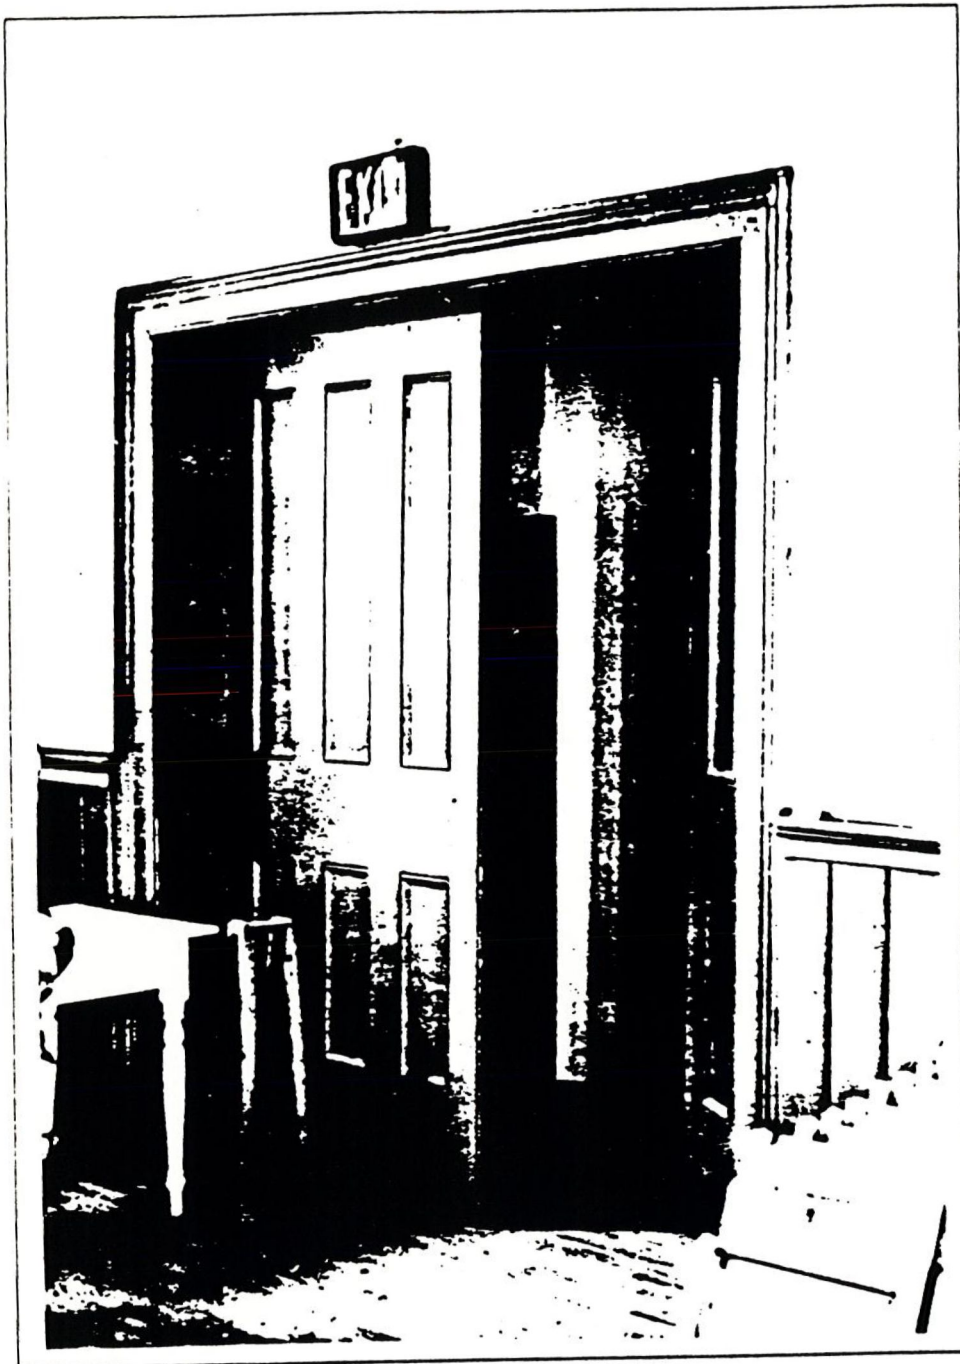
AUDITORIUM ENTRANCE DOORS

Most of the original doors and mouldings still remain in the Auditorium, such as these handsome double doors. The plan advises their restoration.
