INGERSOLL TOWN HALL

HISTORY AND ARCHITECTURE
Analysis and Conservation

prepared by
NICHOLAS HILL
Architect Planner

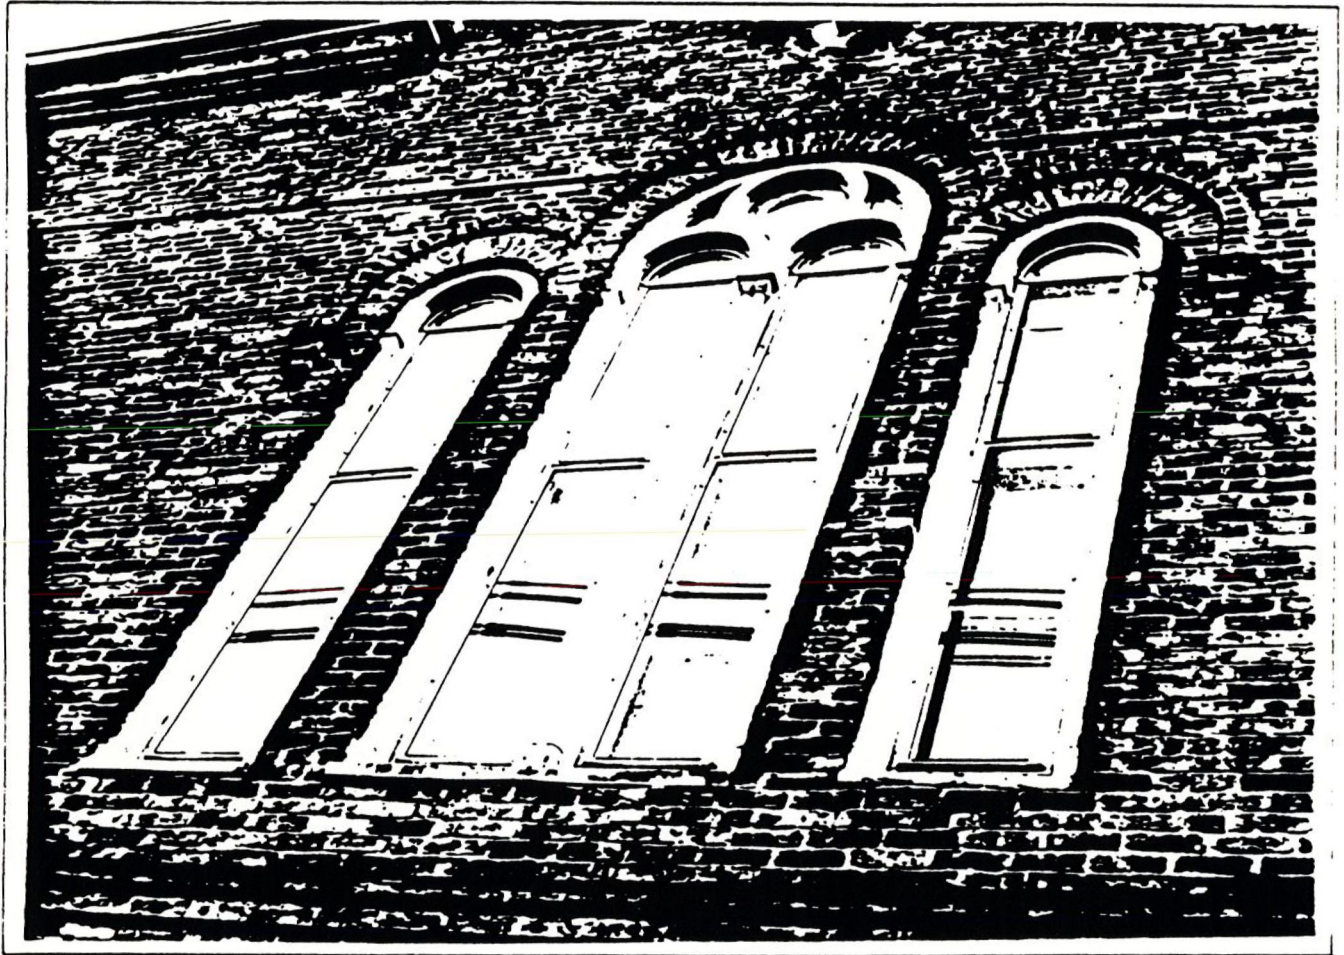
WINDOWS

The windows in the Town Hall are a most attractive feature and are of the Italianate style.

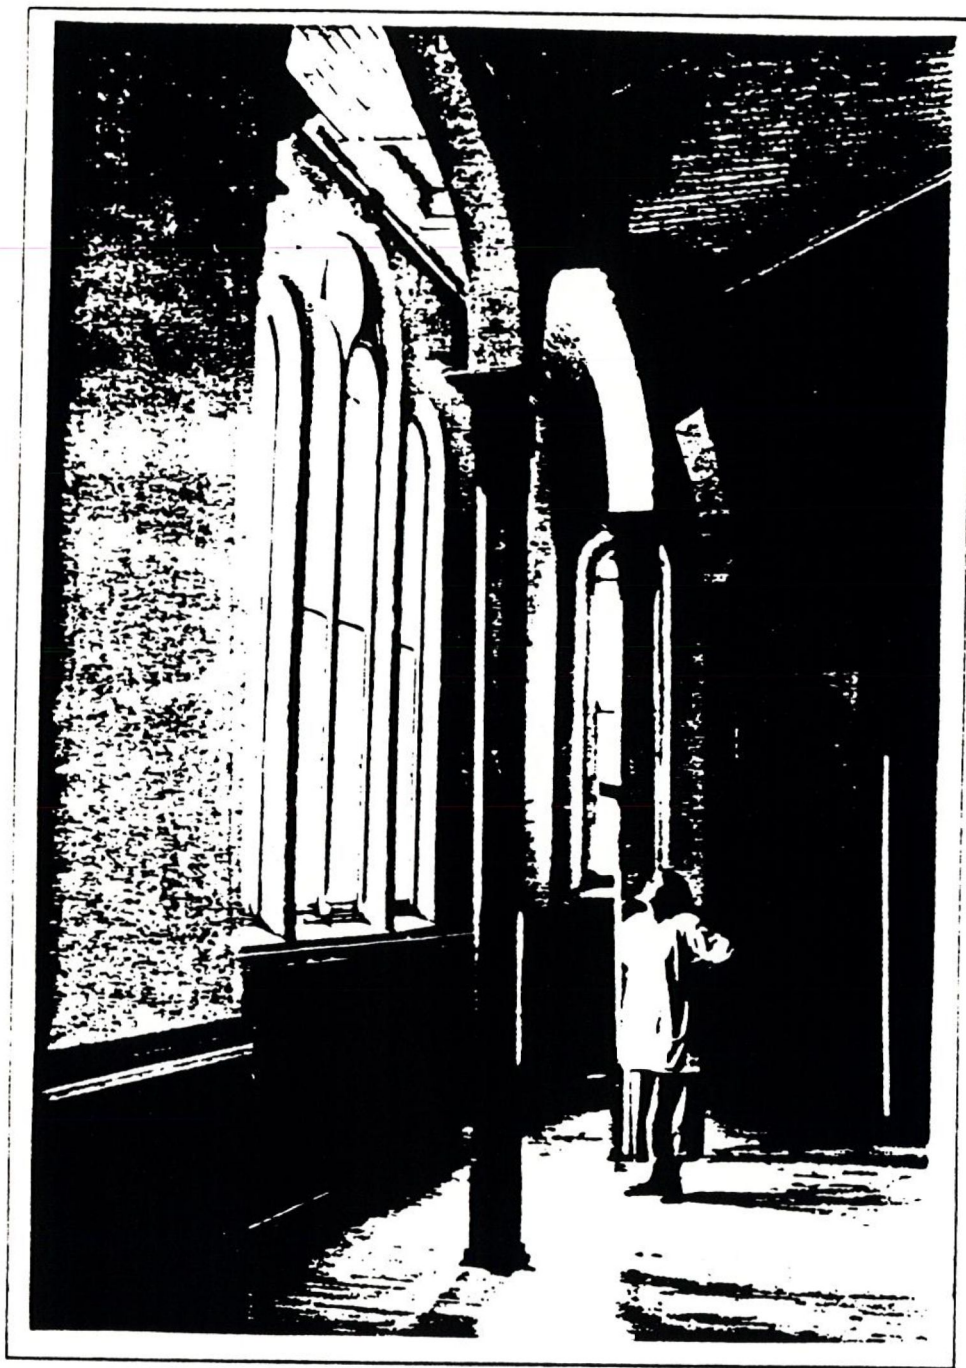
AUDITORIUM FRONT BAY

A bay projects out from the south side of the Auditorium supported by Moorish style columns. The large Italianate window is set off well within the bay.

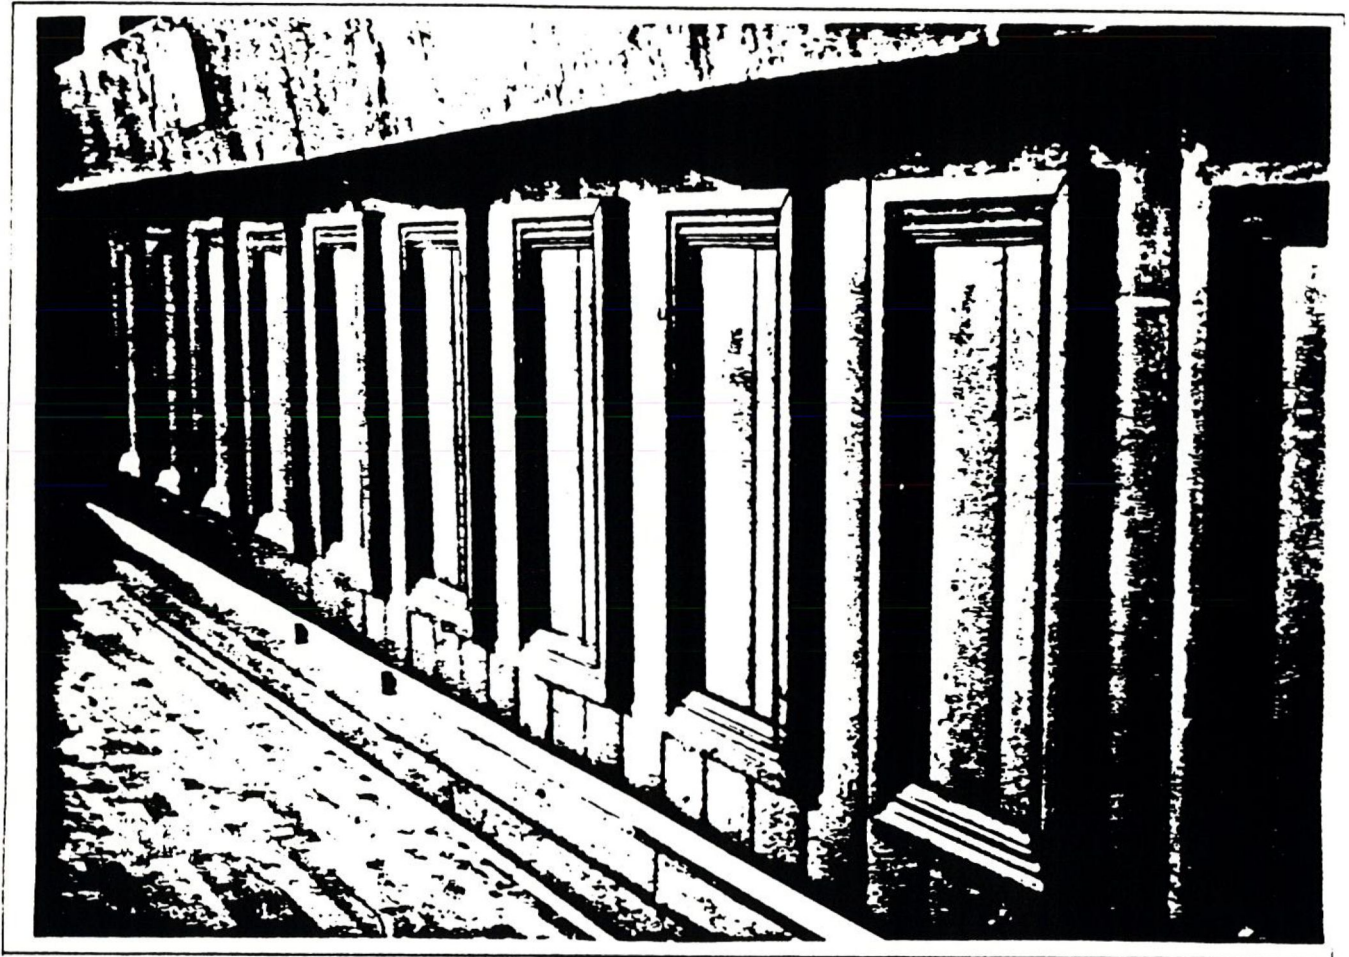
AUDITORIUM STAGE

The Auditorium is a magnificent room with many fine smaller details such as the panelled front, shown here, to the stage.
